FOUNDATION ANALYSIS OF UPPER TUNGA PROJECT AT GAJANUR, SHIMOGA DISTRICT, KARNATAKA

Dr. N. Venkatesh

Cite This Article: Dr. N. Venkatesh, "Foundation Analysis of Upper Tunga Project at Gajanur, Shimoga District, Karnataka", International Journal of Computational Research and Development, Volume 2, Issue 1, Page Number 1-6, 2017.

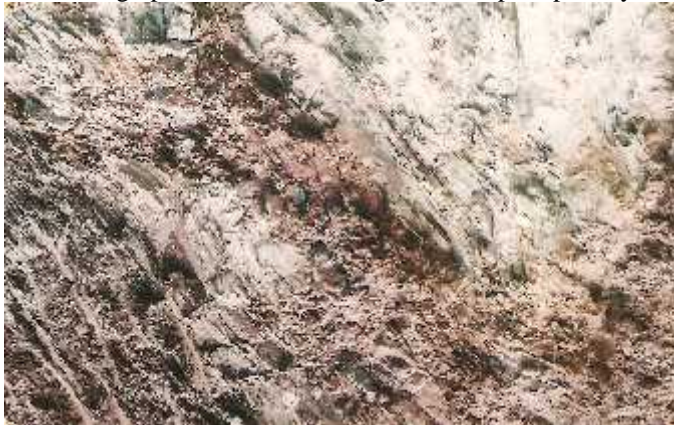
Photograph 2: A View of schistos rock formation excavation of right bank of UTP

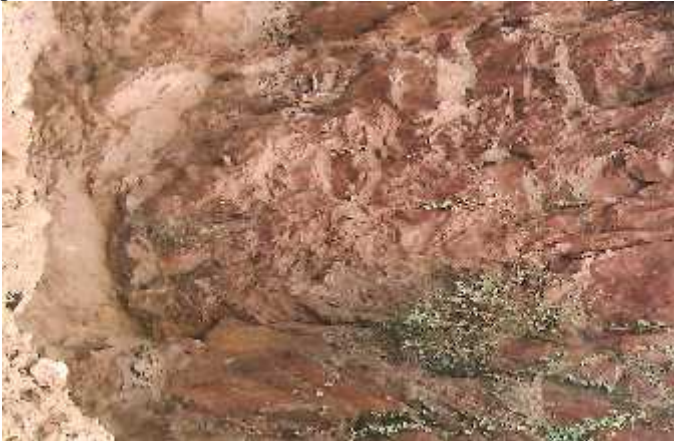
Photograph 3: A View of schistos rock formation excavation of left bank of UTP

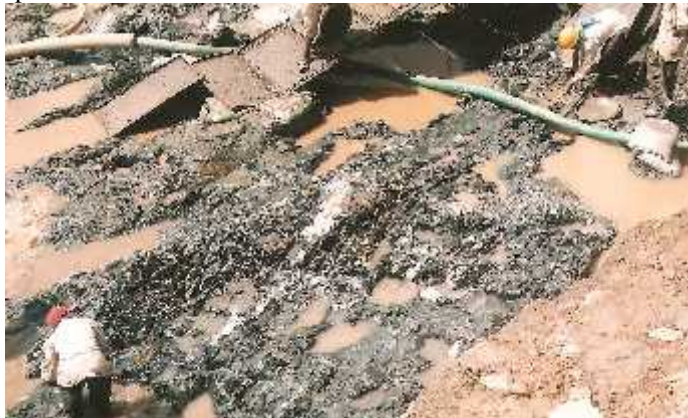
Photograph 4: A View of foundation basement structures of block-17
